# Debris/Ice/TPS Assessment And Photographic Analysis For Shuttle Mission STS-40

July 1991

**Gregory N. Katnik**  
**NASA/Kennedy Space Center**

Shuttle Mission STS-40 was launched at 9:24 a.m. local 6/5/91

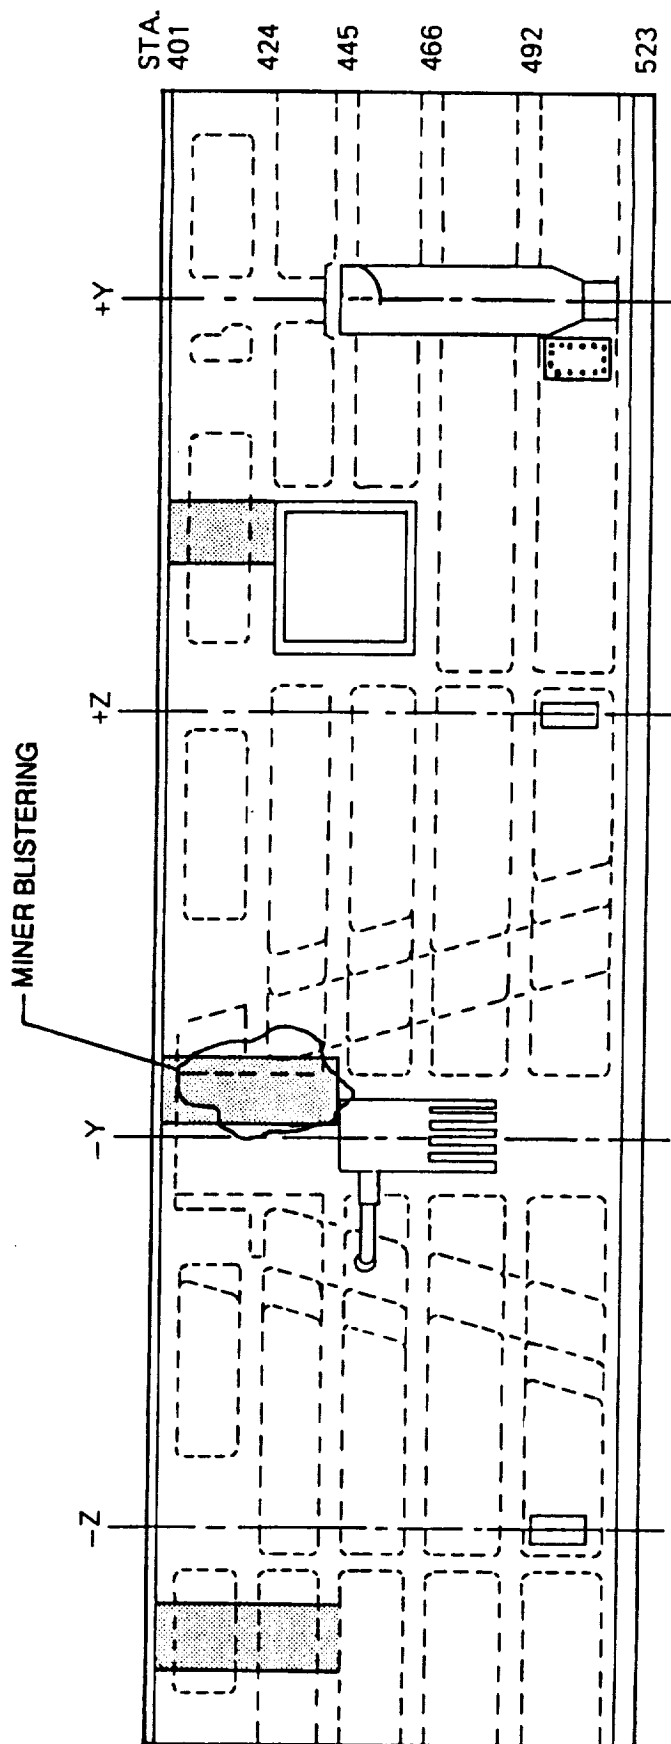
FIGURE 10. RIGHT SRB FWD SKIRT

The RH forward skirt exhibited no debonds or missing TPS. The phenolic plates on both RSS antennae were intact (Figure 10). The forward separation bolt and electrical cables appeared to have separated cleanly. No pins were missing from the frustum severance ring. Minor blistering of the Hypalon paint occurred forward of the ET/SRB attach point.

BLISTERING OF HYPALON  
PAINT WAS MINIMAL.  
RSS ANTENNA PHENOLIC  
PLATES WERE INTACT.

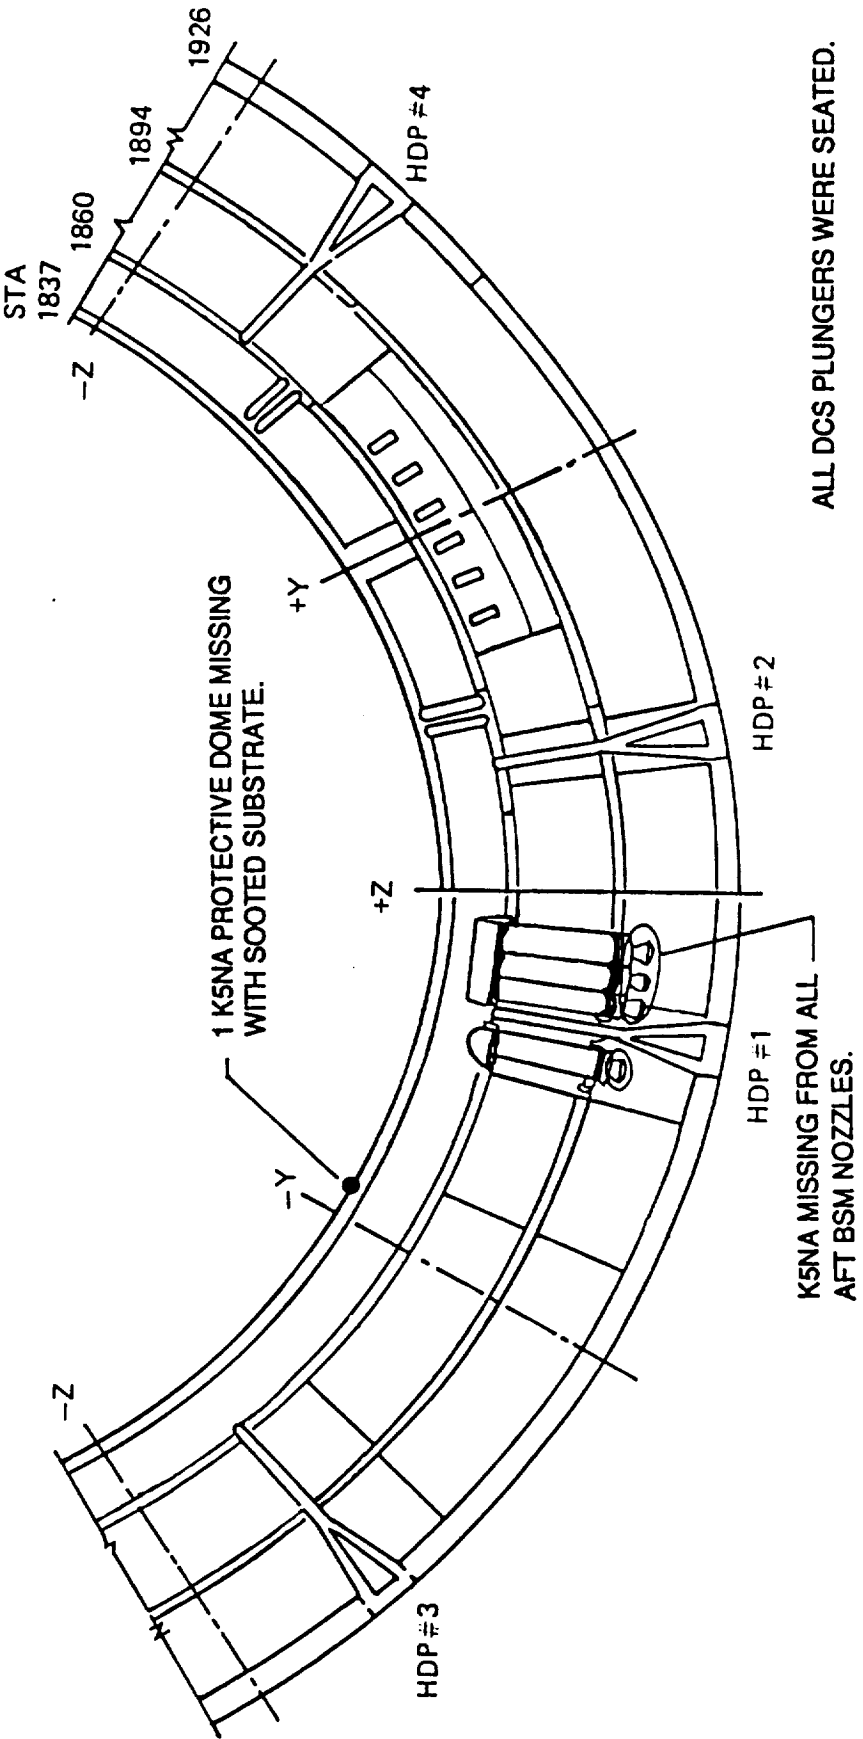
FIGURE 11. RIGHT SRB AFT SKIRT EXTERIOR TPS

The phenolic material on the kick ring delaminated in only a few locations. One of the K5NA protective domes was lost from a bolt head on the aft side of the phenolic kick ring prior to water impact since the substrate was sooted. The aft skirt TPS acreage was in good condition. K5NA was missing from all aft BSM nozzles (Figure 11).

ALL DCS PLUNGERS WERE SEATED.

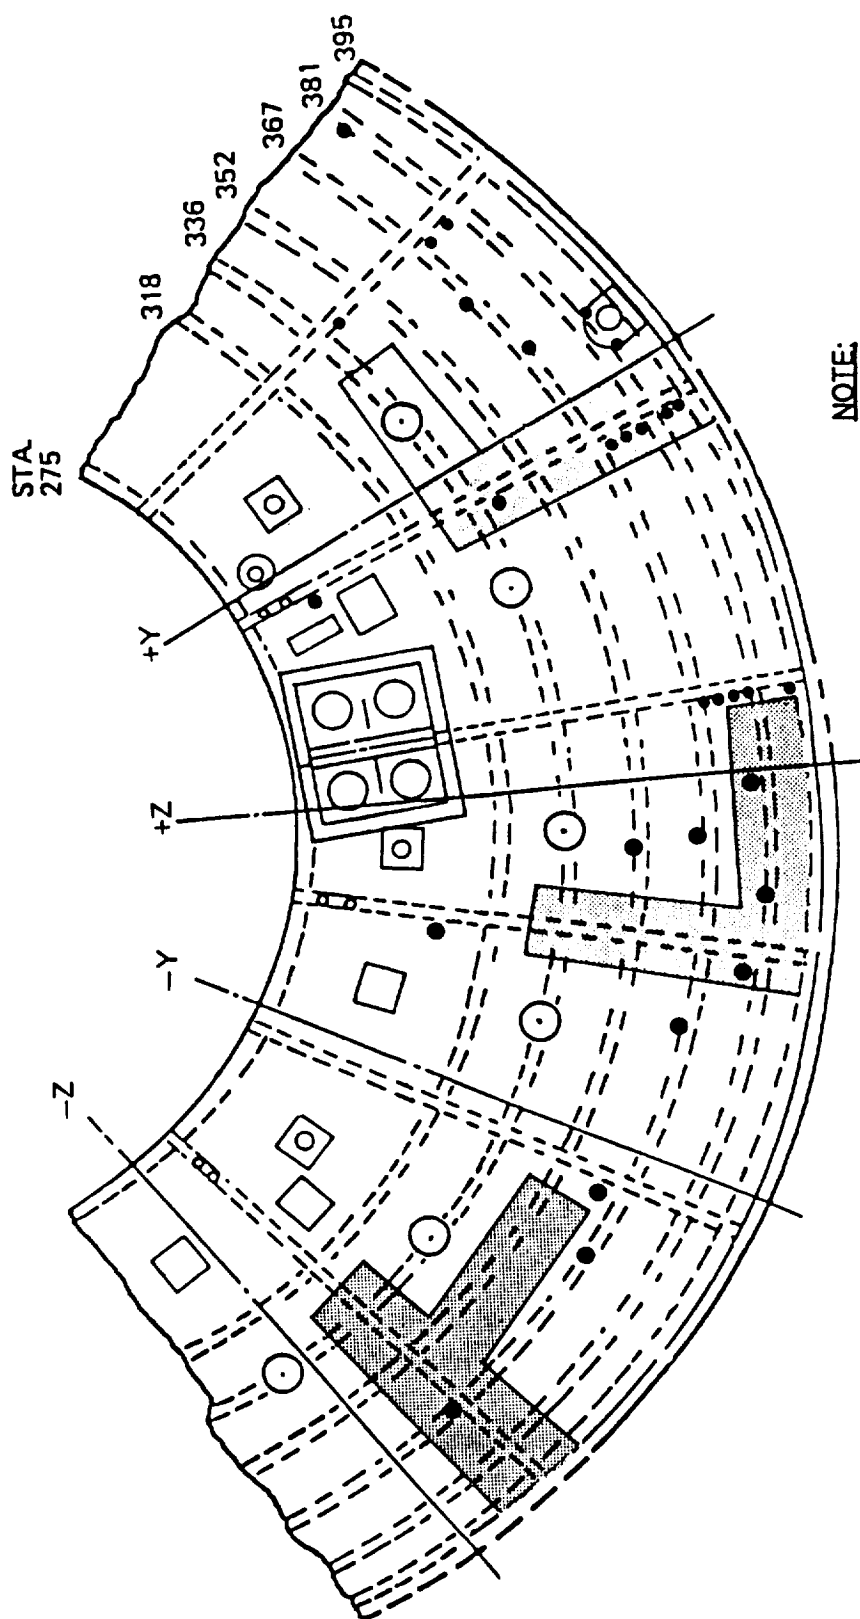
FIGURE 12. LEFT SRB FRUSTUM

The nose cap was not recovered. The LH frustum was missing no TPS but had 30 MSA-2 debonds over fasteners (Figure 12). Minor blistering of the Hypalon paint occurred at three locations. All BSM covers were locked in the fully opened position.

ALL BSM COVERS WERE  
LOCKED IN THE OPEN  
POSITION.  
BLISTERING OF HYPALON  
PAINT WAS MINIMAL.

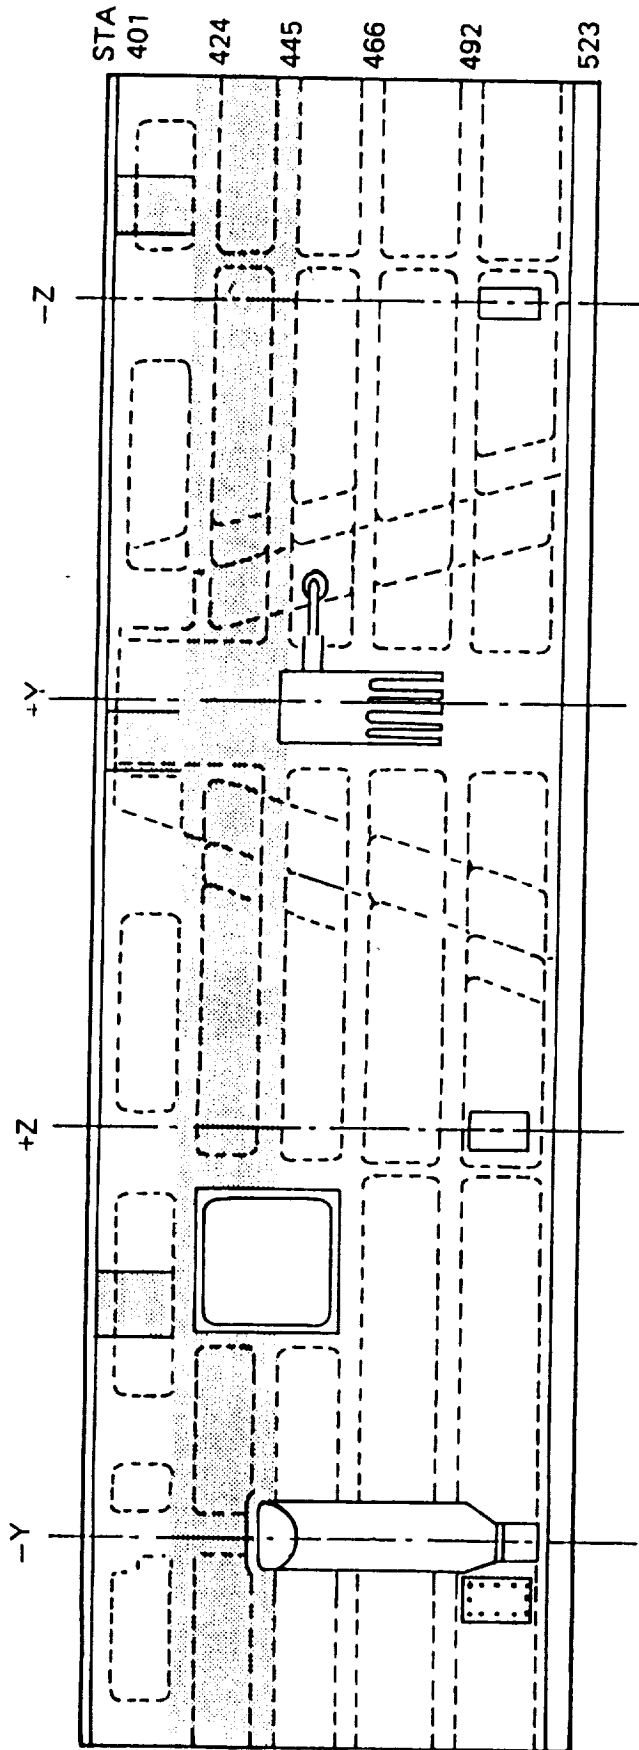
FIGURE 13. LEFT SRB FWD SKIRT

The LH forward skirt exhibited no debonds or missing TPS. The phenolic plates on both RSS antennae were intact (Figure 13). The forward separation bolt and electrical cables appeared to have separated cleanly. No pins were missing from the frustum severance ring. Minor blistering of the Hypalon paint occurred forward of the ET/SRB attach point.

NOTES:  
BLISTERING OF HYPALON  
PAINT WAS MINIMAL.  
PHENOLIC PLATES ON RSS  
ANTENNAE WERE INTACT.

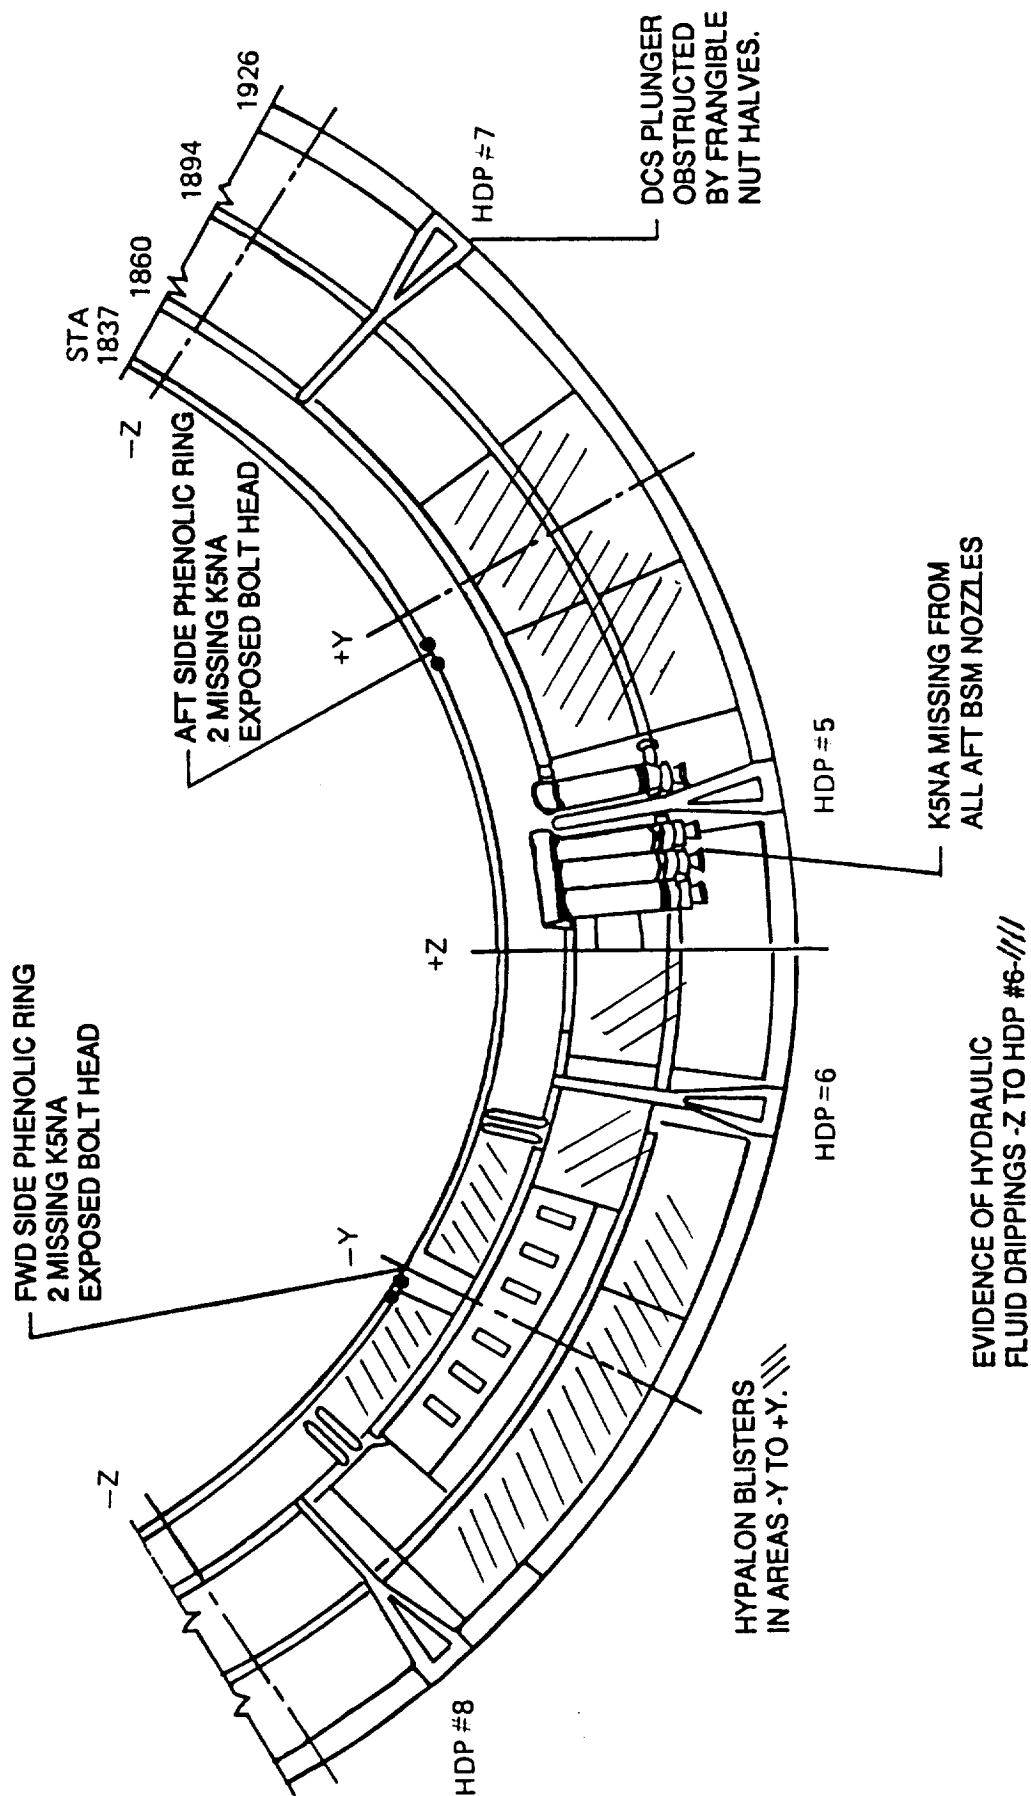
FIGURE 14. LEFT SRB AFT SKIRT EXTERIOR TPS

The phenolic material on the kick ring delaminated in only a few locations. Some K5NA protective domes were lost from bolt heads on the aft side of the phenolic kick ring prior to water impact. The aft skirt TPS acreage was in good condition. K5NA was missing from all aft BSM nozzles (Figure 14).

The HDP Debris Containment System (DCS) plungers were seated with the exception of HDP #7, which was obstructed by frangible nut halves. EPON shim material was missing from the aft skirt after water impact, but none of the substrate was charred.

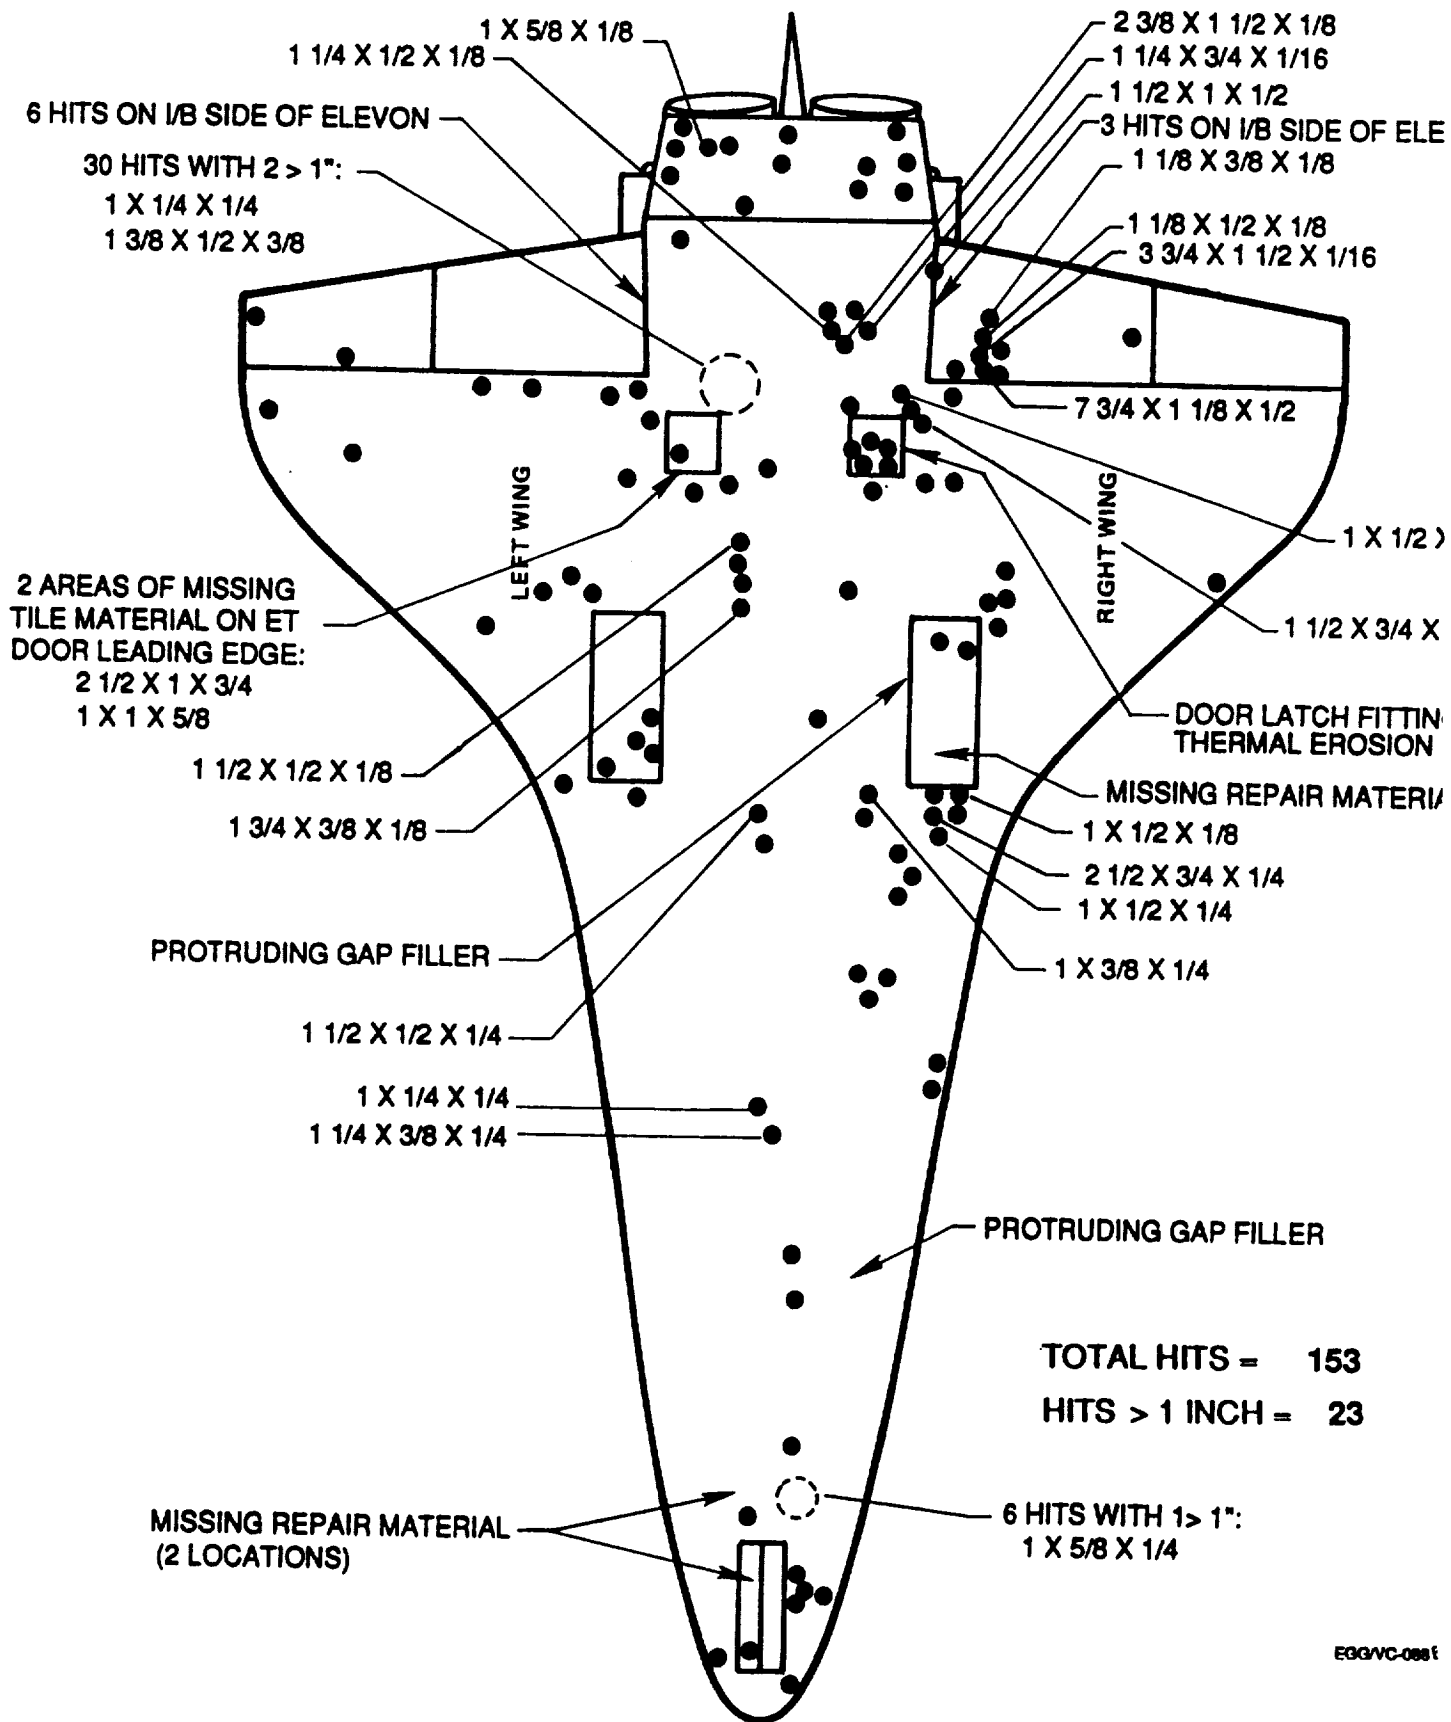
**FIGURE 15. STS-40  
DEBRIS DAMAGE LOCATIONS**

The Orbiter lower surface had a total of 153 hits of which 23 had a major dimension of one inch or greater. A comparison of these numbers to statistics from 27 previous missions of similar configuration (excluding missions STS-24, 25, 26, 26R, 27R, and 30R which had damage from known debris sources), indicates both the total number of hits and the number of hits with a major dimension of 1 inch or larger on the lower surface was greater than average. Figures 15-18 show the TPS debris damage assessment for STS-40. Figure 19 indicates the sites where samples were taken for laboratory chemical analysis.

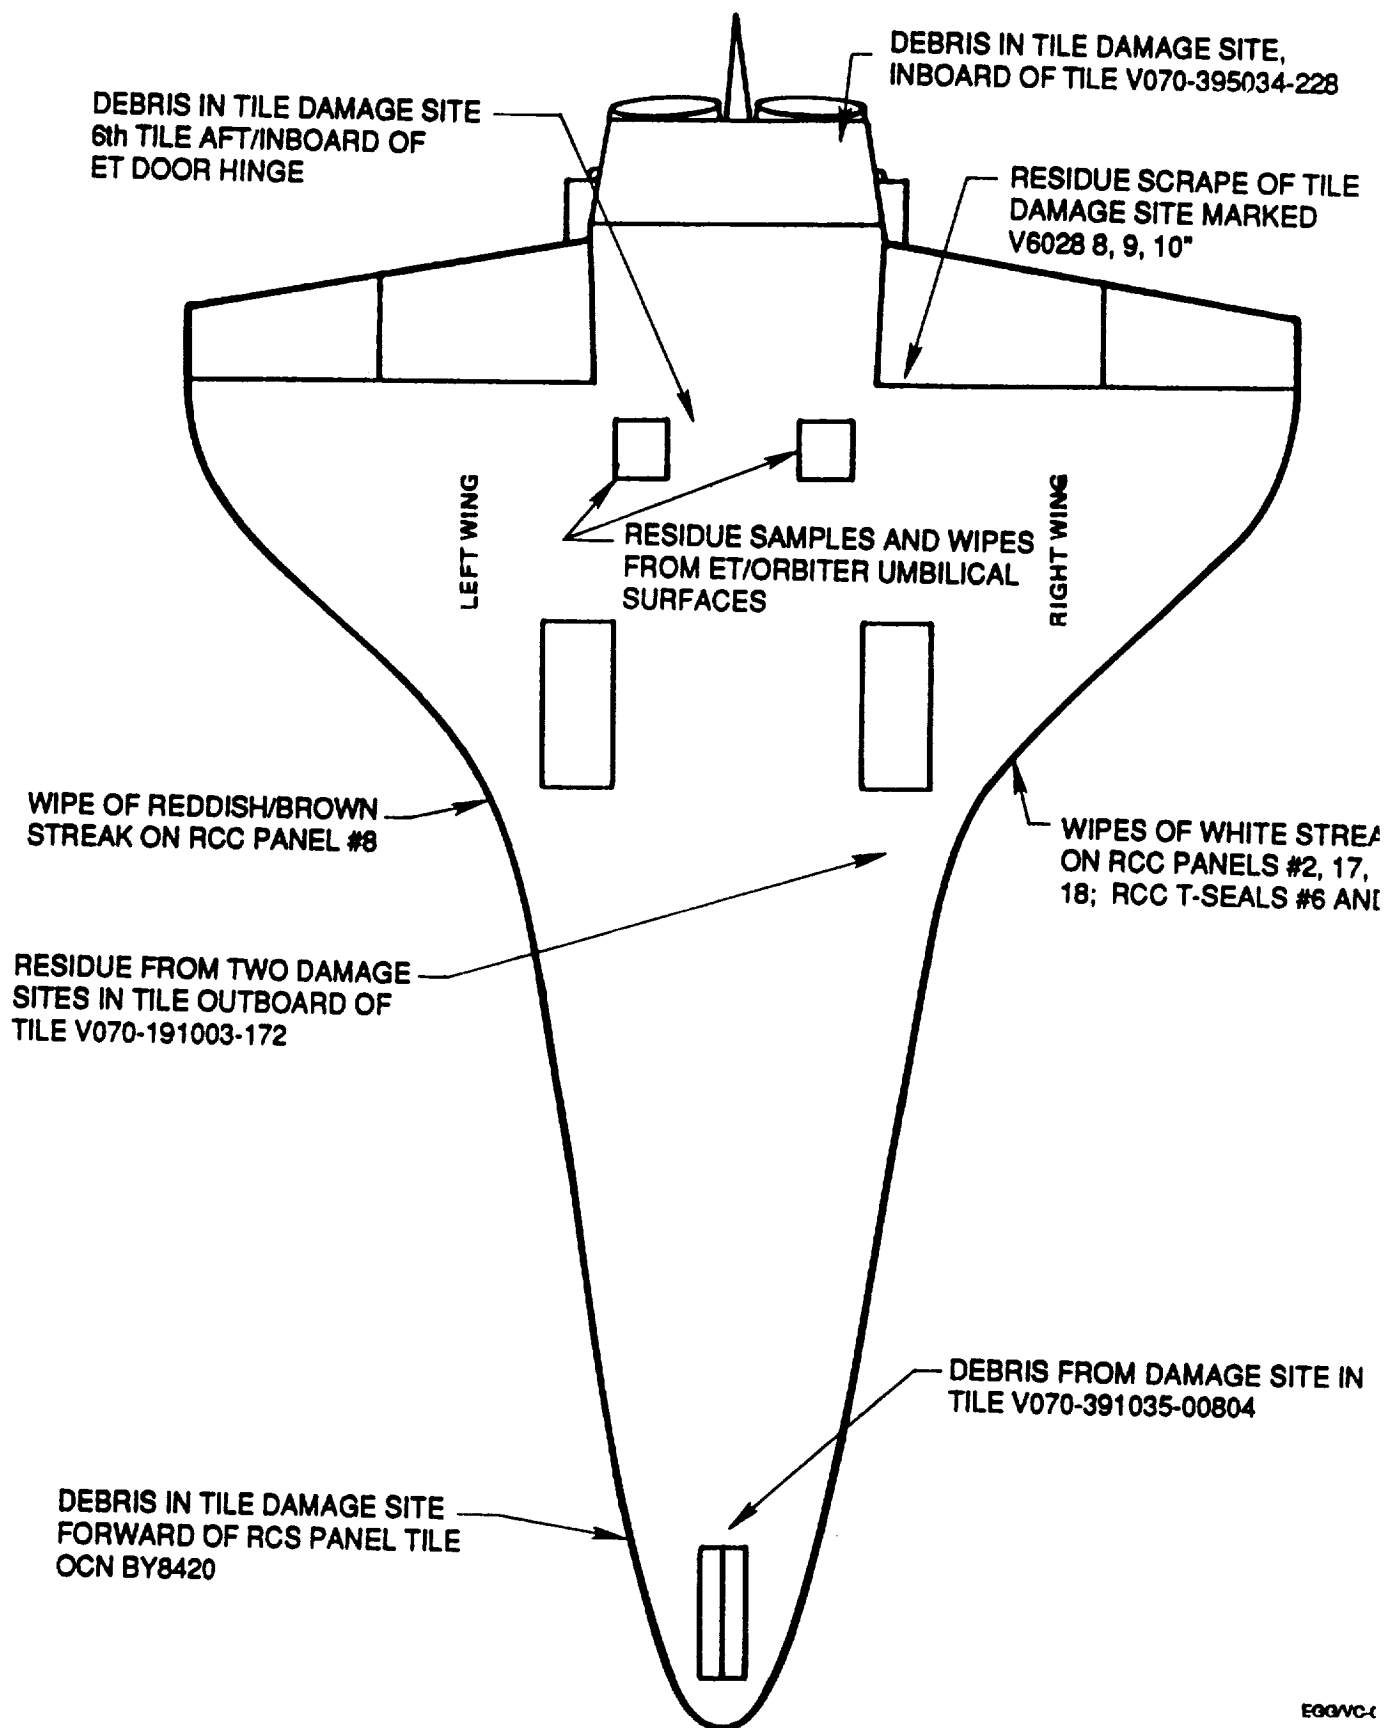
FIGURE 19. **STS-40  
CHEMICAL SAMPLE LOCATIONS**

White streaks were present on the RH wing leading edge RCC panels #2, 17, and 18; and T-seals #6 and 11. A reddish-brown streak was present on the LH wing leading edge RCC panel #8. Samples of selected streaks were taken for laboratory analysis (Figure 19).

A total of 24 samples were obtained from Orbiter OV-102 during the STS-40 post landing debris assessment at Ames-Dryden Flight Research Facility (ADFRF), California (Figure 19). The 24 submitted samples consisted of 8 Orbiter window wipes (W 1-8), 6 wing leading edge RCC samples (5RH, 1LH), 7 tile residue samples, and 3 ET-ORB umbilical wipes (1LH2, 2LO2). The samples were analyzed by the NASA KSC Microchemical Analysis Branch (MAB) for material composition and comparison to known STS materials. The specific elemental analysis is shown in the appended MAB report. Debris analysis involves the placing and correlating of particles with respect to composition, thermal (mission) effects, and availability. Debris sample results and analyses are listed by Orbiter location in the following summaries.

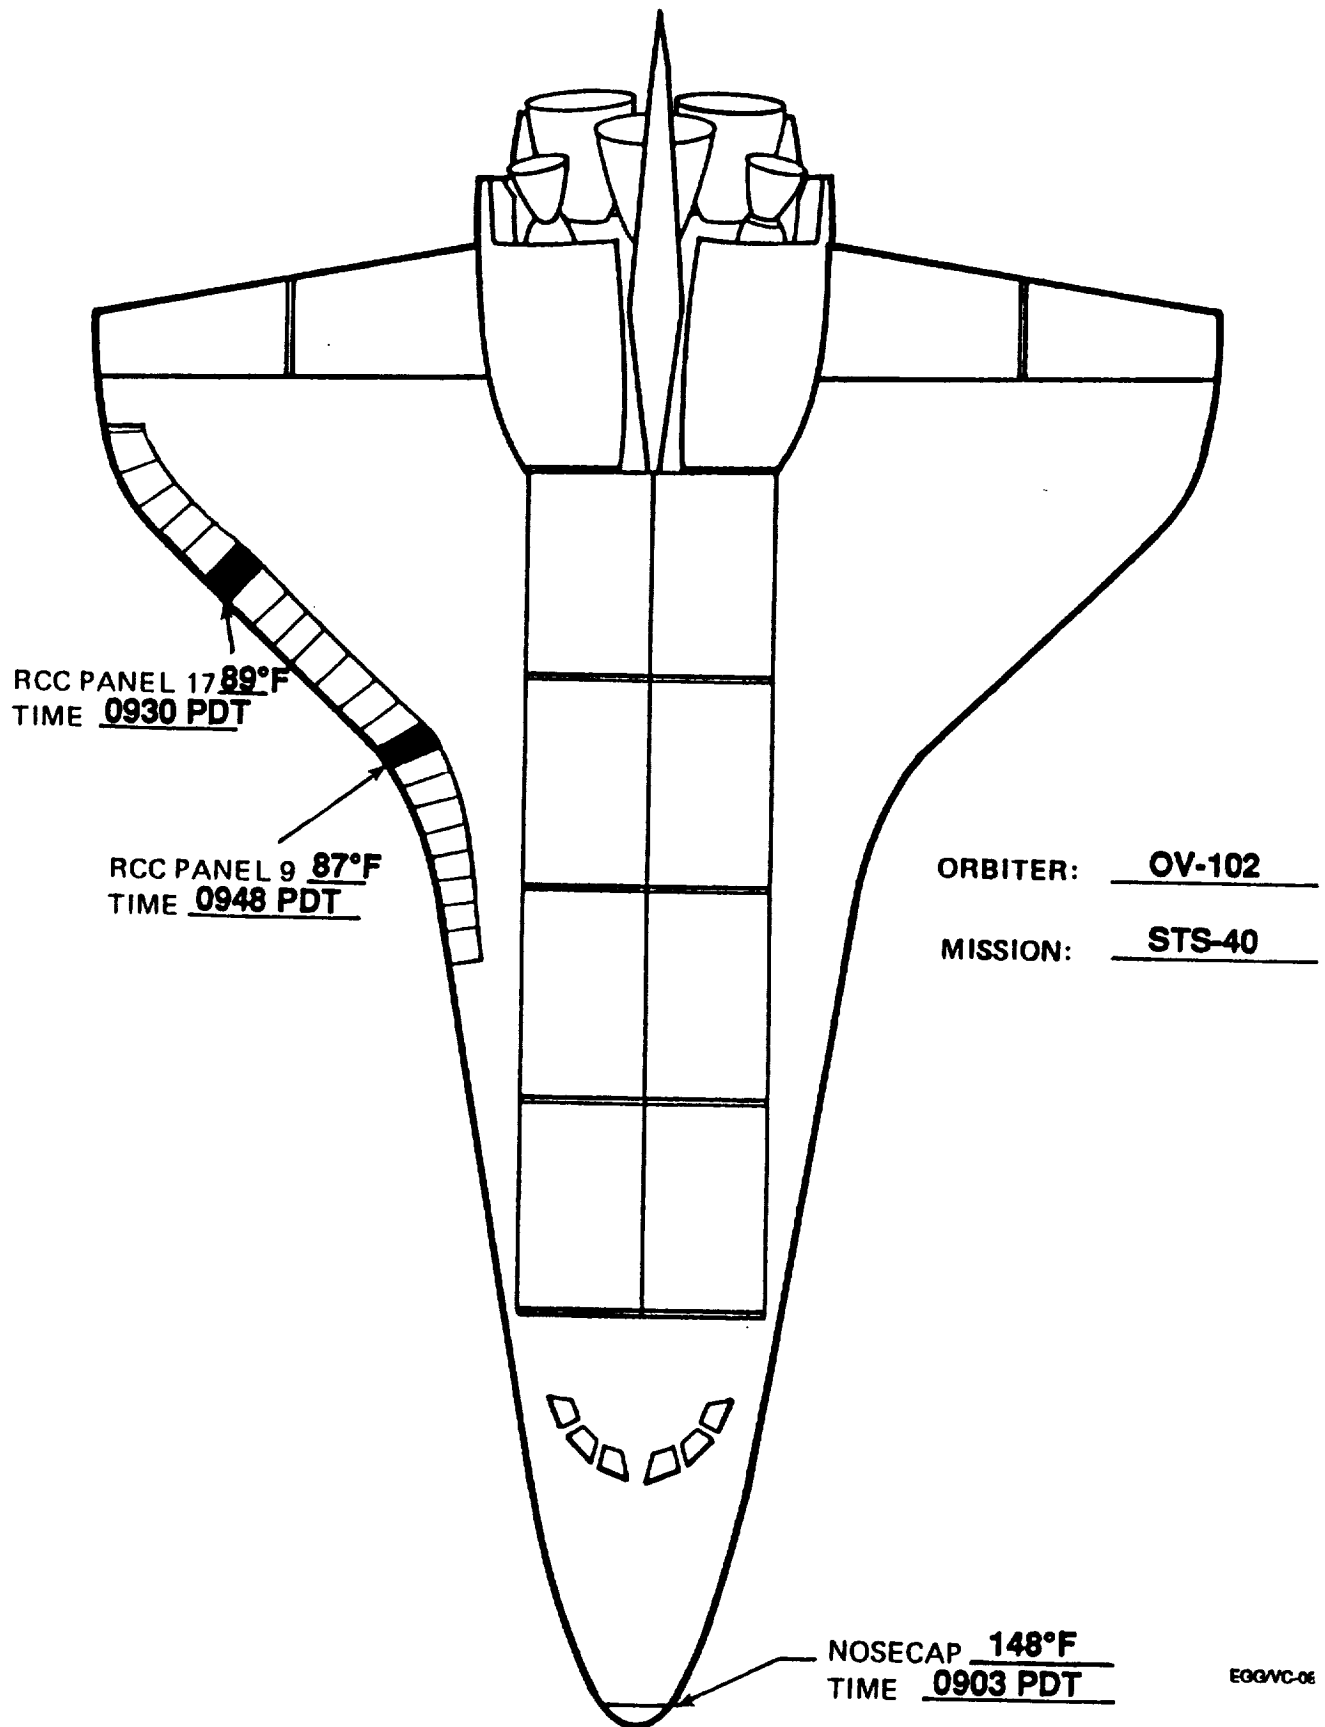
FIGURE 20. **STS-40 RCC TEMPERATURE MEASUREMENTS AS  
RECORDED BY THE SHUTTLE THERMAL IMAGER  
TEMPERATURE MEASUREMENTS**

The KSC Shuttle Thermal Imager (STI) was used to measure the surface temperatures of several areas. Twenty-four minutes after landing, the Orbiter nose cap RCC was 148 degrees F. The RH wing leading edge RCC panel #9 was 87 degrees F sixty-nine minutes after landing. Fifty-one minutes after landing the RH wing panel #17 was 89 degrees F (Figure 20).

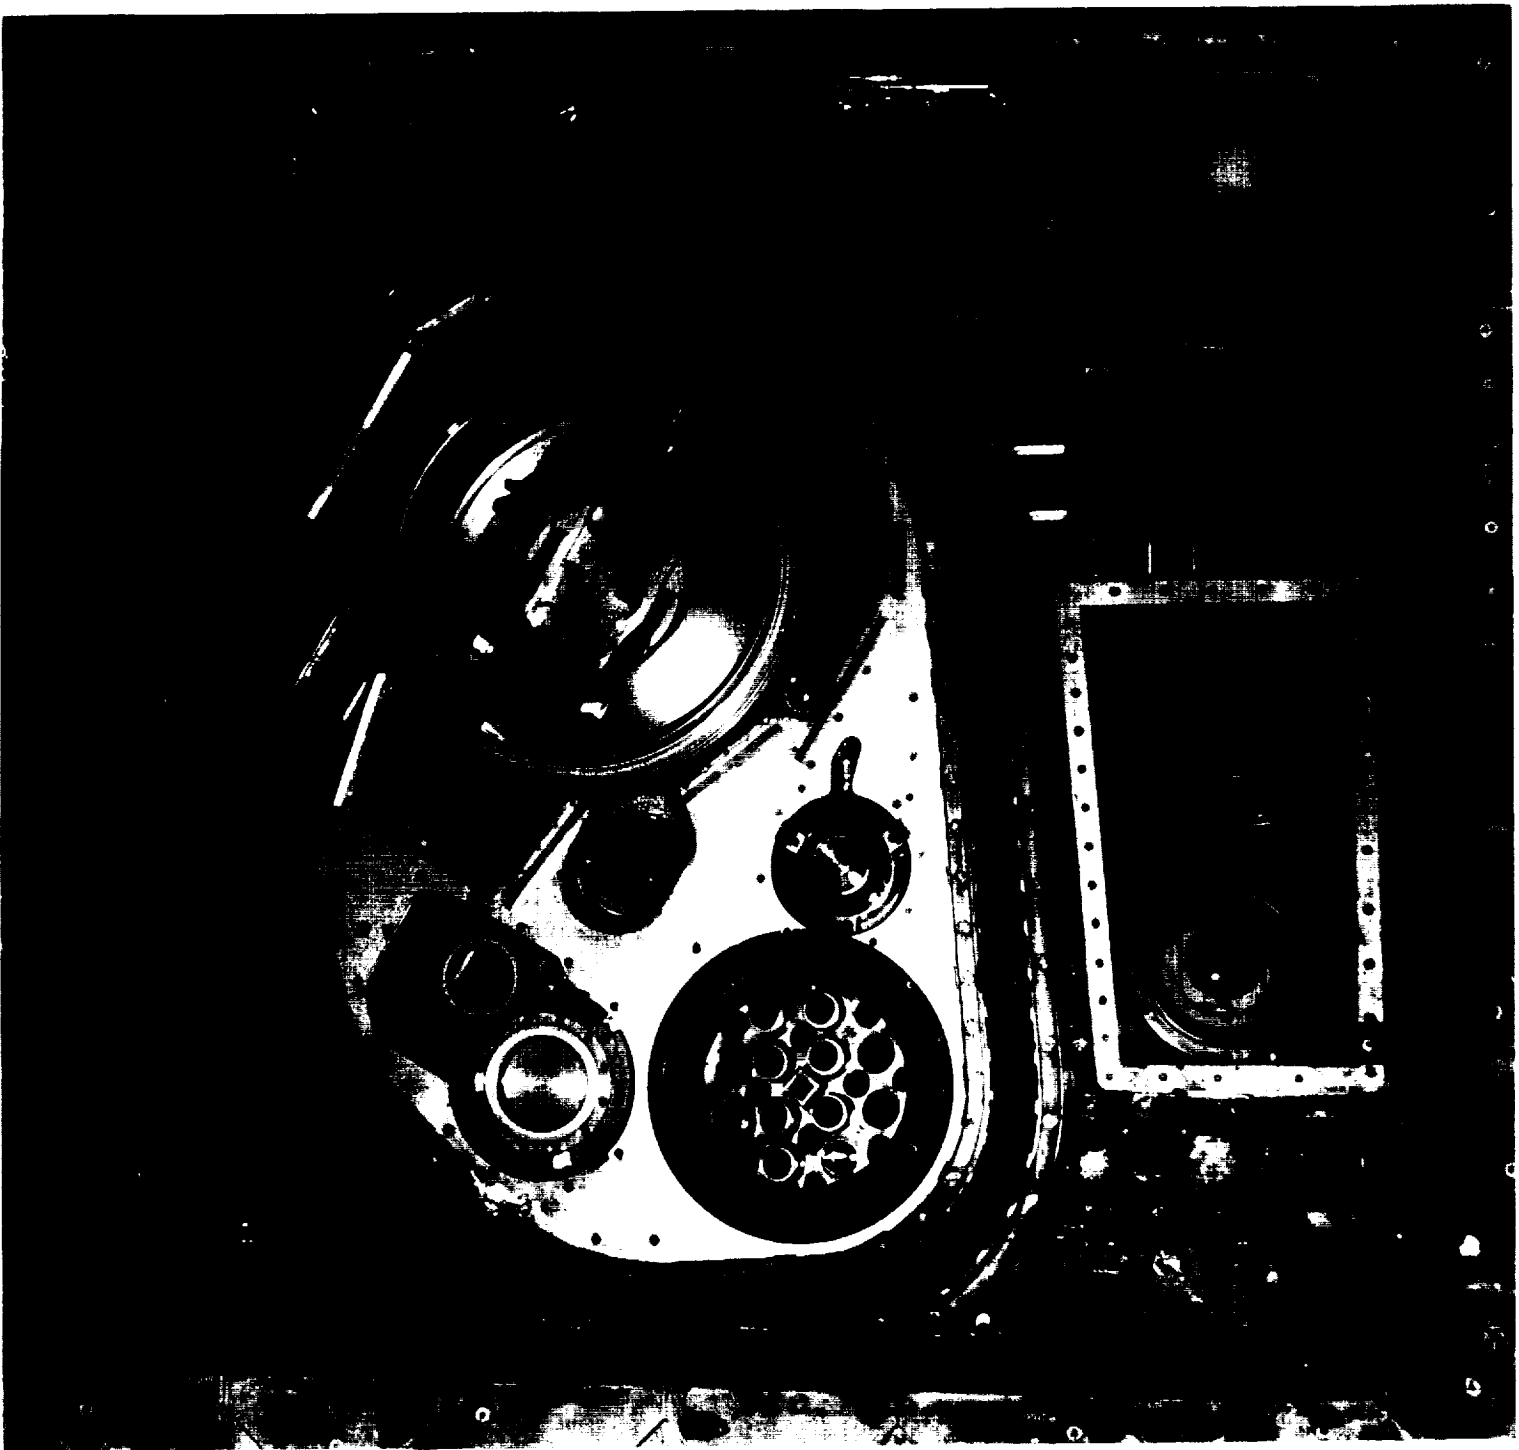
Overall view of the LH2 ET/ORB umbilical cavity. No hardware was missing. There was no galling or raised metal on the shear pins that could be associated with the loss of the LH2 ET/ORB shear pin bushing during ET separation.
